FRAME INSPECTION REPORT & DEFECTS LIST

TABLE OF CONTENTS

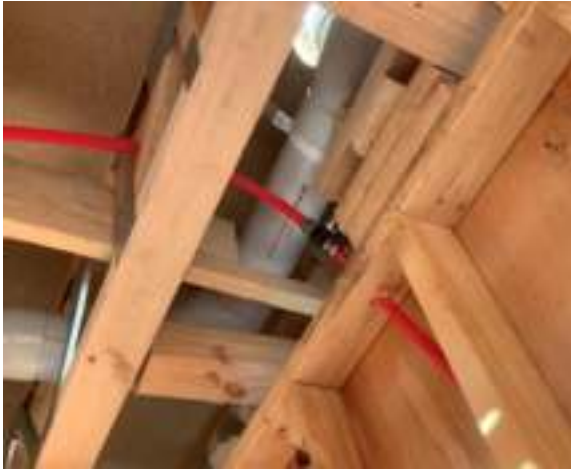
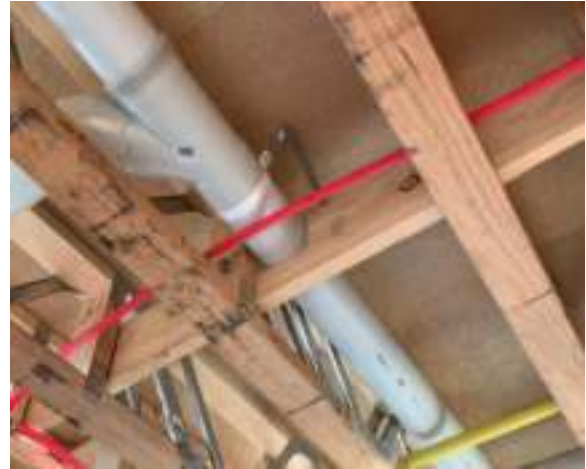
1. Posi Truss Strongback Cut

The strongbacks have been cut for services to run through, without any additional framework installed.
Area: Laundry in 2 x areas

The manufacturer states that *'Strongbacks significantly dampen vibrations and increase the stiffness of the floor system. The performance of the floor depends very much on the proper installation of Strongbacks'*.

The additional battens must be installed, or the manufacturer contacted to provide a proper solution.

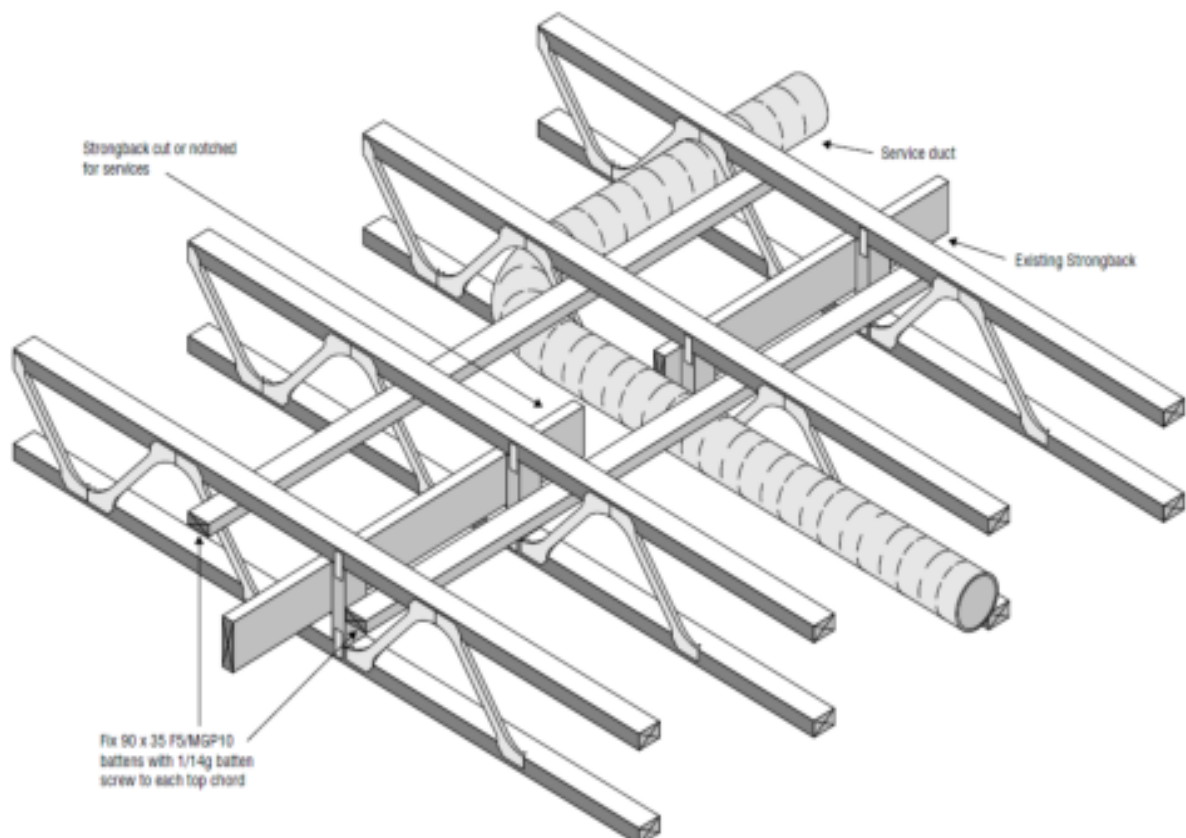
The manufacturer has a modification detail for this, which states *'Where a strongback has to be cut (or notched) to run a service duct through it, a compensating pair of 90x35 F5/MGP10 battens may be fixed to the underside of the top chord, on each side of the strongback, as shown below. The battens should extend across 3 PosiStrut spacings. Multiple cuts in a strongback should not be less than 3 PosiStrut spacings apart, or additional measures will be required.'*

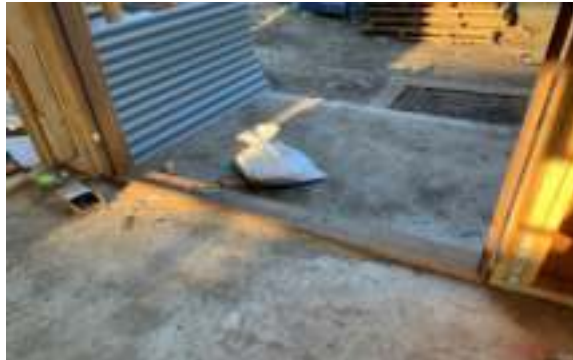
2. Door Sill Flashing

The timber door frames have not had a sill flashing installed in accordance with the requirements of Part 3.5.3.6 Flashings to Wall Openings of the Building Code of Australia (BCA), which will allow water to penetrate in under it into the finished floor.

Area: Entry

The Victorian Building Authority's Guide to Standards and Tolerances clause 8.02 Weather-tightness of windows, doors, and window and door frames states that *'Windows and doors are defective if they are not sealed in accordance with the requirements of the Building Code of Australia'*.

The frame will now have to be removed and the sill properly flashed before it is re-installed with attention paid to the flashing beings turned down into the cavity.

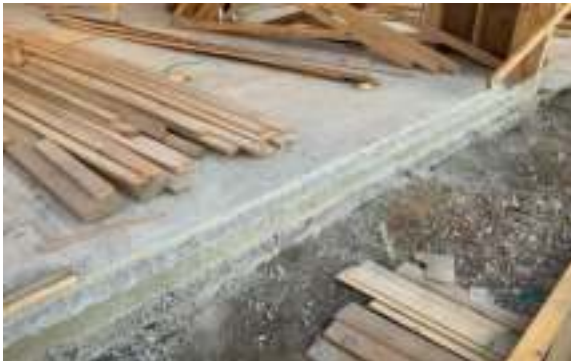
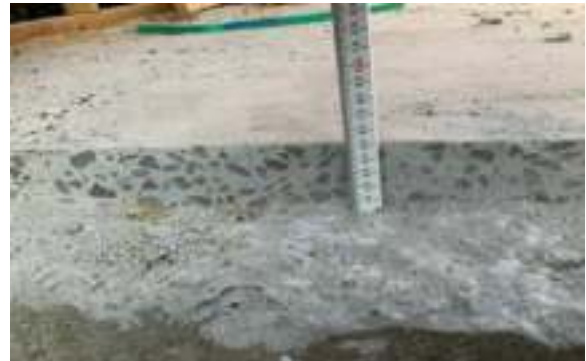
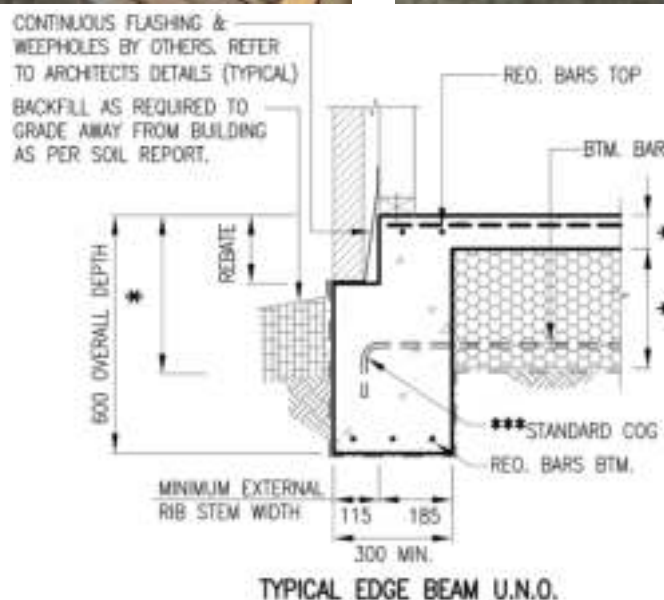
3. Concrete Chase Cut

The top of the floor slab in Rear beam under door frame has been cut/chased, which would have either exposed or cut away the steel reinforcement mesh from within it, compromising the slab's integrity.

Area: Rear beam under door frame

The builder must have the original design engineer inspect and make recommendations on the acceptability of these cuts to ensure the slab's long-term performance. The owner should request a copy of the engineer's comments and/or recommendations and ensure that any rectification work is carried out under the supervision and approval of the building surveyor.

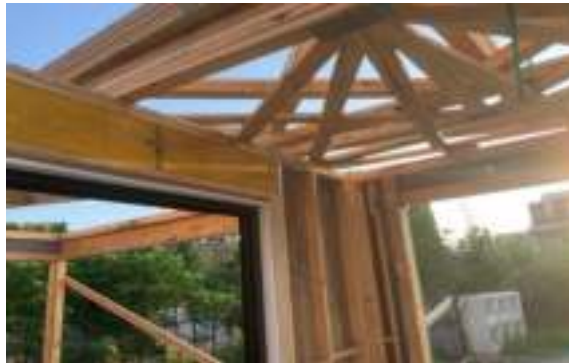
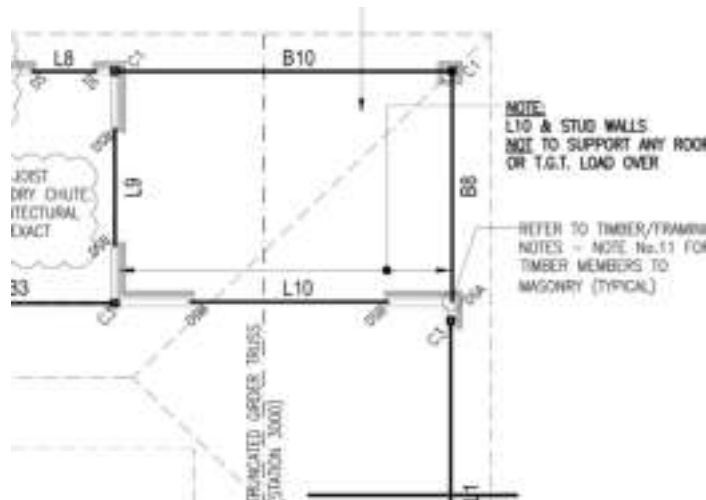
4. Engineering Item

The wall frame and lintel over the living room sliding door frame has been constructed with a double top plate (ribbon plate) which will be supporting roof truss load, despite the note on the engineering drawings stating that it must not carry any load.

This must be rectified prior to works in this area proceeding any further.

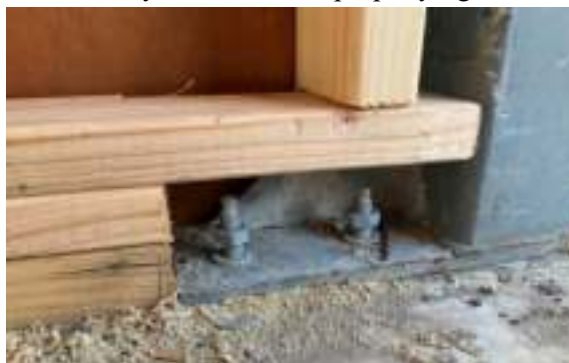
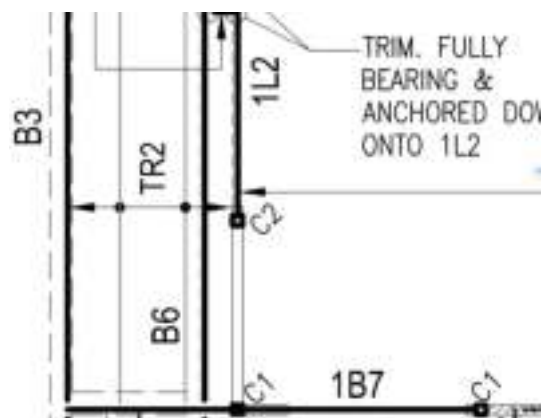
5. Column Nuts Loose

The nuts on the “C2” column in the study have not been properly tightened.

This must be rectified prior to works in this area proceeding any further.

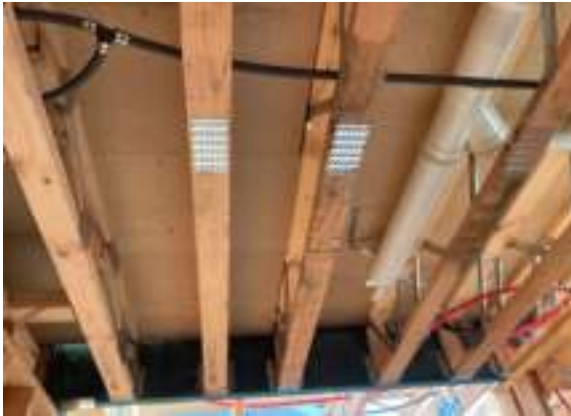
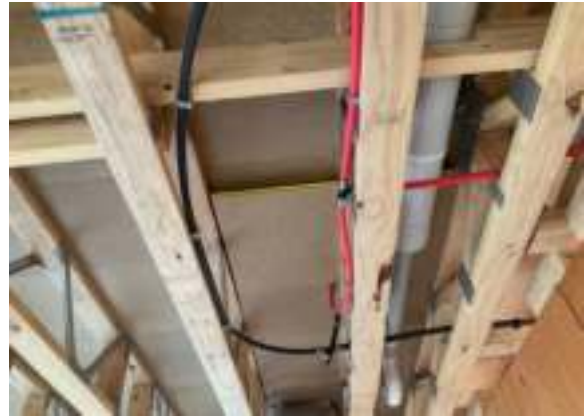
8. Flooring Not Supported

The flooring in this area has an unsupported join in it.
Area: Bathroom shower step-down over laundry area

The relevant Australian Standard AS 1860.2 Particleboard Flooring – Installation in section 9.1 Panel Installation – General Requirements states that *‘Square edge joints shall be butted centrally over joists or trimmers’*.

The builder will need to provide solid blocking/trimmers to support this flooring.

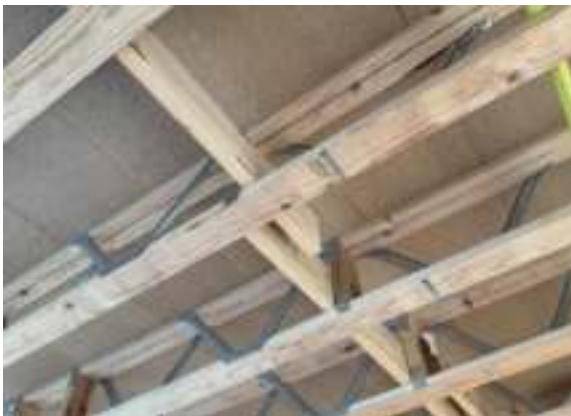
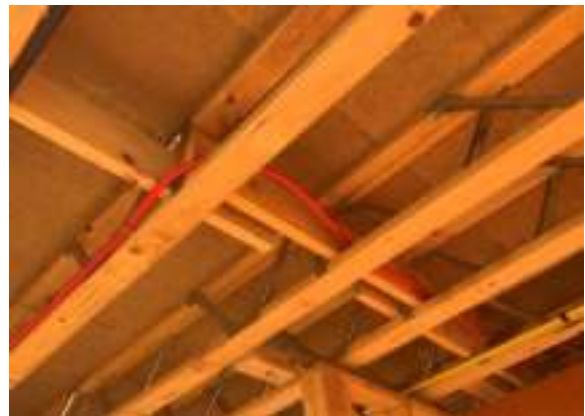
9. Posi Truss Strongback Span Change

The strongbacks have not been properly connected to the joists at the span changes.
Area: Study & kitchen

The manufacturer states that *‘Strongbacks significantly dampen vibrations and increase the stiffness of the floor system. The performance of the floor depends very much on the proper installation of Strongbacks’*.

The strongback must be properly fixed in accordance with the manufacturer’s instructions to ensure the performance of the floor frame system.

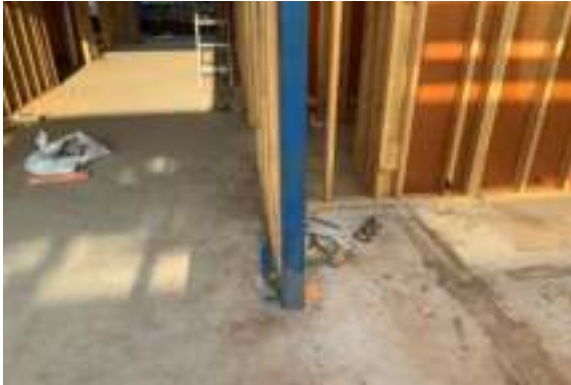
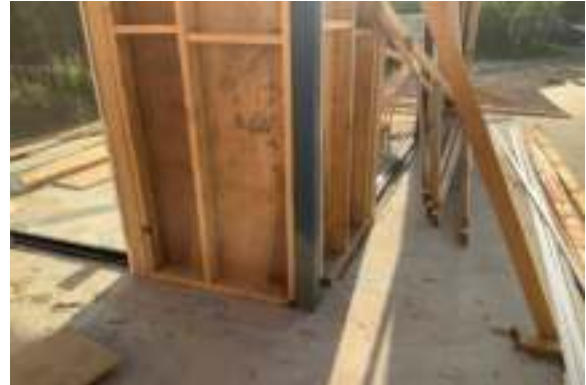
10. Plaster Stud Steel Column

The steel columns have not all been installed to allow for the fixing of the future plasterboard sheets at 300mm centres along the external corners.

Area: Rumpus

The relevant Australian Standard AS 2589.1 Gypsum Linings in Residential and Light Commercial Construction – Application and Finishing, clause 7.6.2 Spacing, requires that ***‘Plasterboard shall be fastened at a maximum of 300mm centres for internal angles, external corners and around openings’***.

This column should have been set back to allow framing members to be attached, to properly support the plasterboard joint at the corners. As the plaster doesn't have the correct support for fixings at 300mm centres, future cracking of the plasterboard in this area is very possible, and should be the ongoing responsibility of the builder into the future, beyond ordinary warranty periods, unless properly addressed.

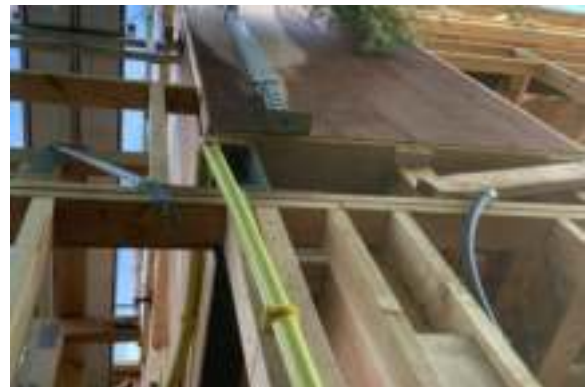
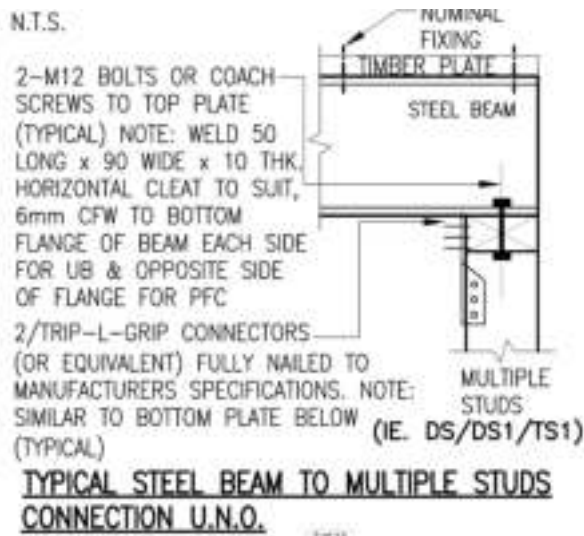
11. Engineering Connection Incorrect

This engineered connection has not been constructed as detailed on the engineering drawings.

Area: “1B5” to wall in master suite

This will need to be re-constructed on site to reflect the designed requirements of the approved drawings, or otherwise be re-designed and certified by the original design engineer. The building permit may also need to be amended by the relevant building surveyor to reflect the changes to the approved drawings.

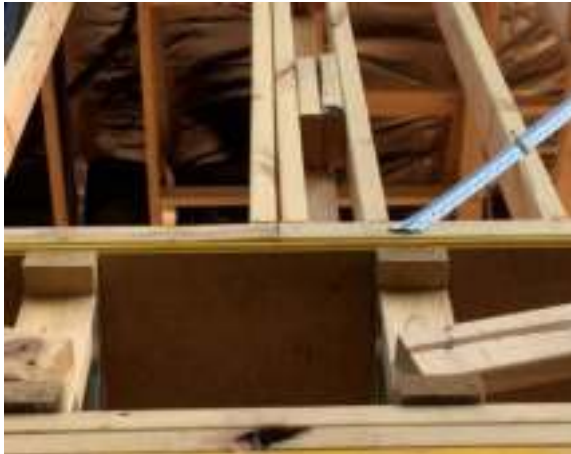
12. Bottom Plate Unsupported Join

There are joins in the bottom plates that have not been supported by a joist or solid blocking.
 Area: Above ensuite window

The relevant Australian Standard AS 1684 Residential Timber-Framed Construction, clause 6.2.2.2 Bottom Plates states *'Bottom plates may be butt-jointed provided both ends are fixed and supported by floor joists, solid blocking or a concrete slab'*.

This bottom plate join must be properly supported to comply with the above standard.

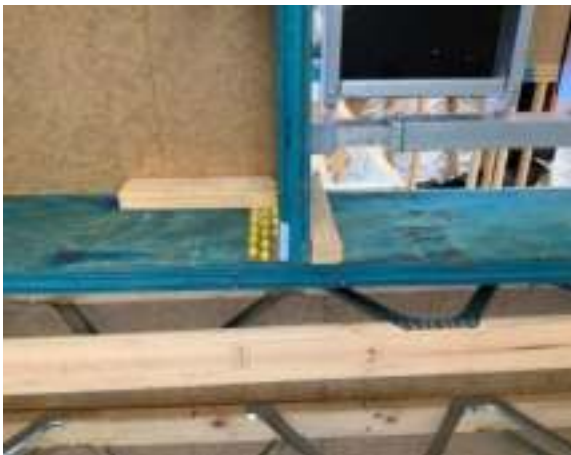
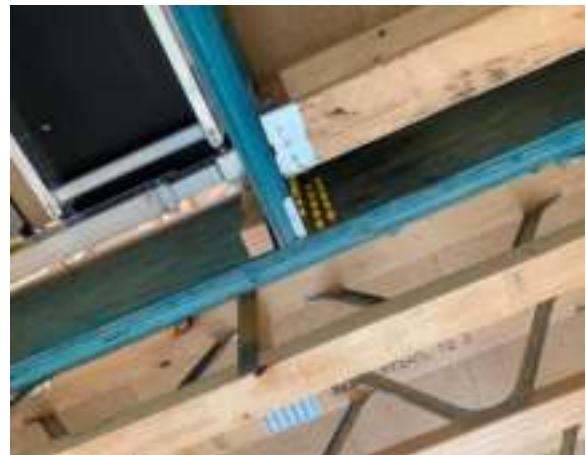
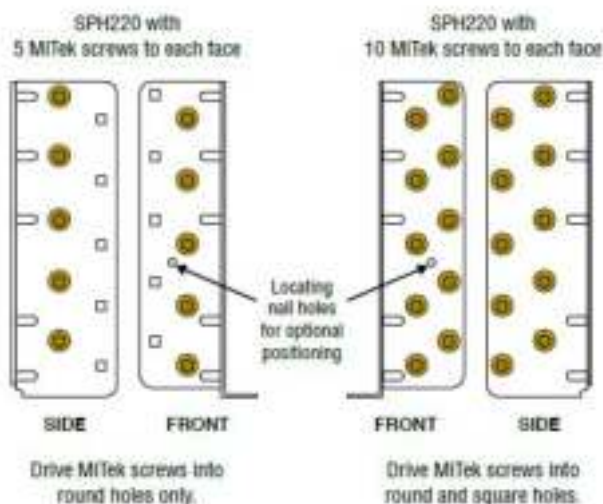
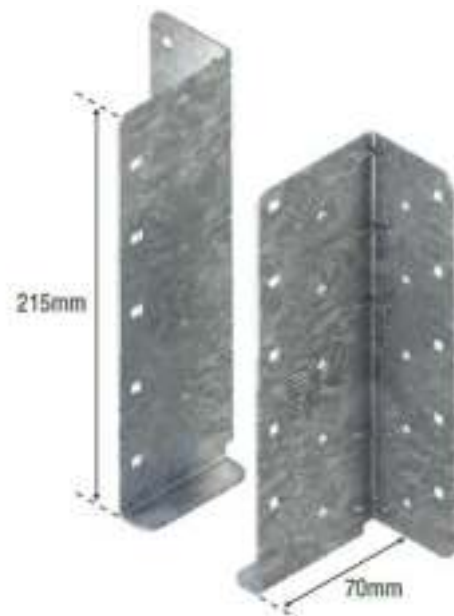
13. Split Hanger Missing

There is a split hanger missing on the floor frame.
 Area: Stairwell beam should have bracket on both sides

This must be immediately installed to prevent the floor frame from possible failure.

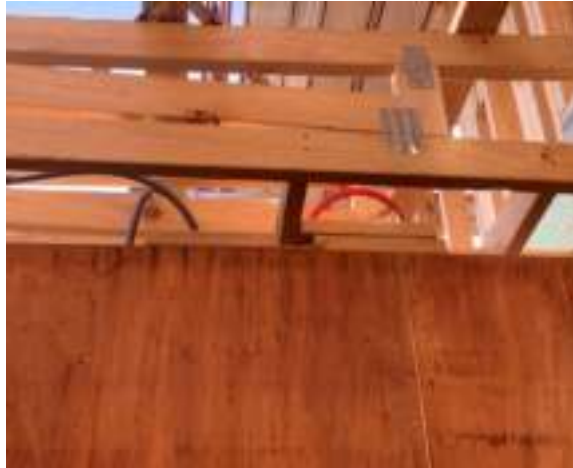
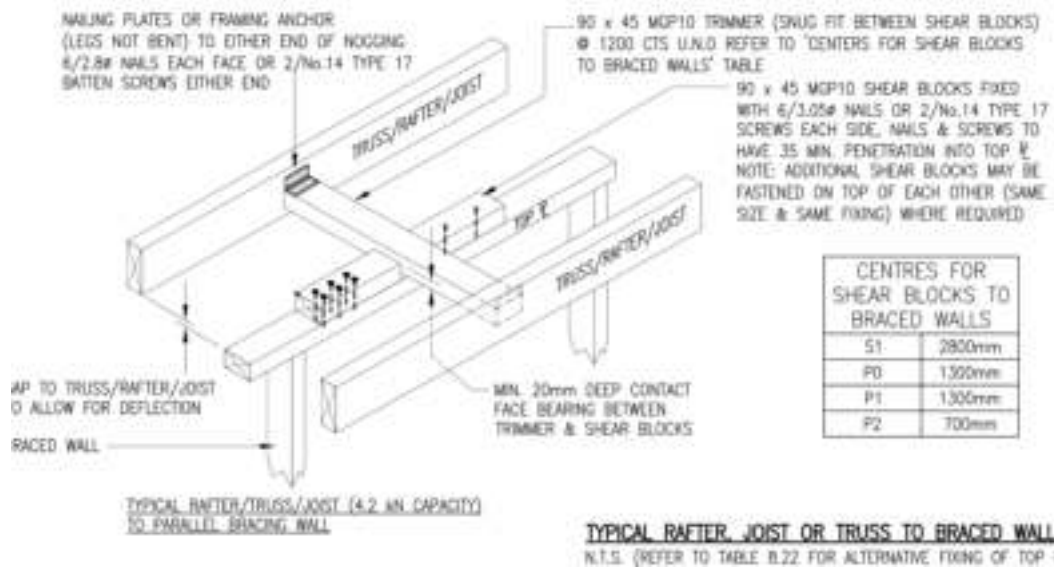
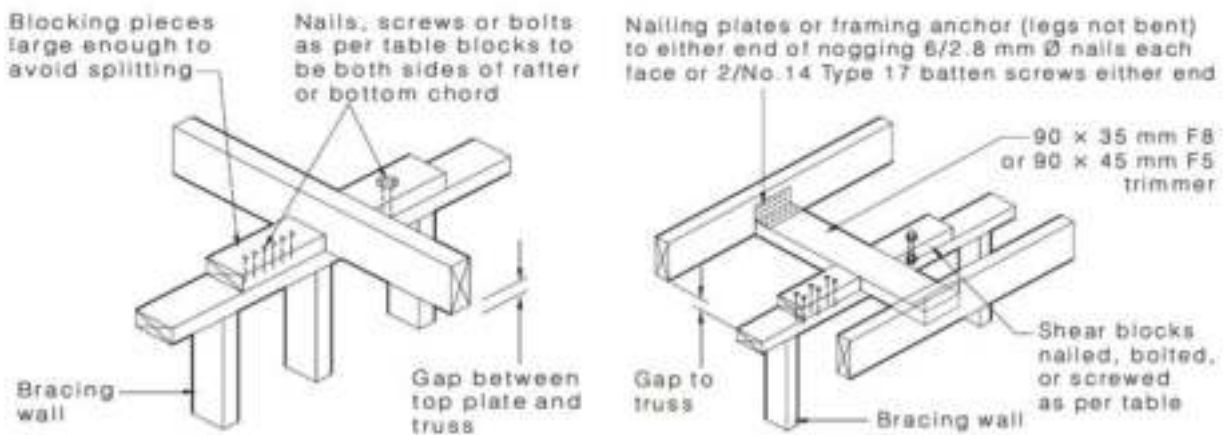
14. Shear Block Missing

There are shear blocks missing over internal braced walls throughout this home.
Area: Study/laundry wall

The relevant Australian Standard AS 1684 Residential Timber-Framed Construction, clause 8.3.6.9 Fixing of Top of Bracing Walls states that *'All internal bracing walls shall be fixed to the floor of lower storey bracing walls, the ceiling or roof frame, and/or the external wall frame, with structural connections of equivalent shear capacity to the bracing capacity of that particular bracing wall'*.

These missing structural connections must be properly installed to the tops of the internal braced walls in accordance with AS 1684.

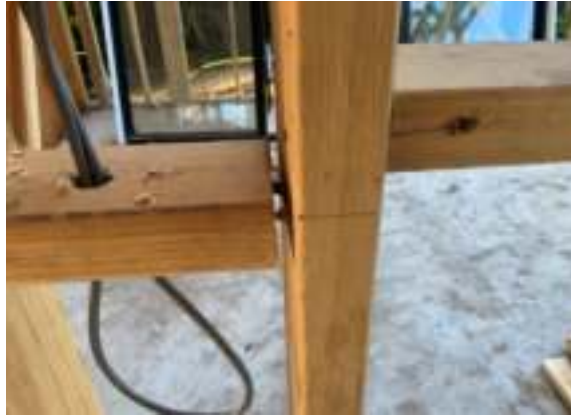
15. Nogging Short

There are noggings between the wall studs that are short, allowing the studs to move behind the plaster sheeting, which could lead to the future cracking of the plaster joints.

Area: Entry/Master wall

The relevant Australian Standard AS 1684 Residential Timber-Framed Construction – Simplified, clause 6.2.1.5 Nogging, states *'Wall studs shall have continuous rows of noggings, located on flat or on edge, at 1350mm maximum centres'*.

All of these wall noggings must be properly installed to be tight between the studs.

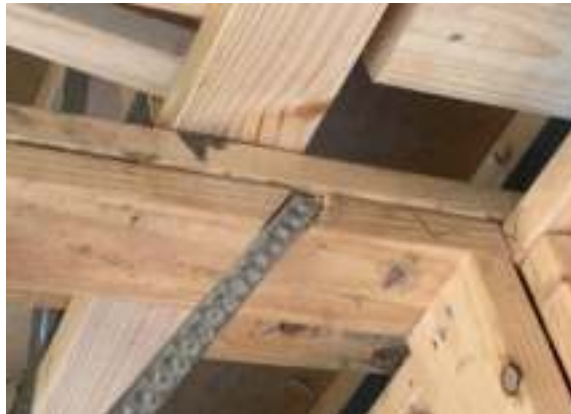
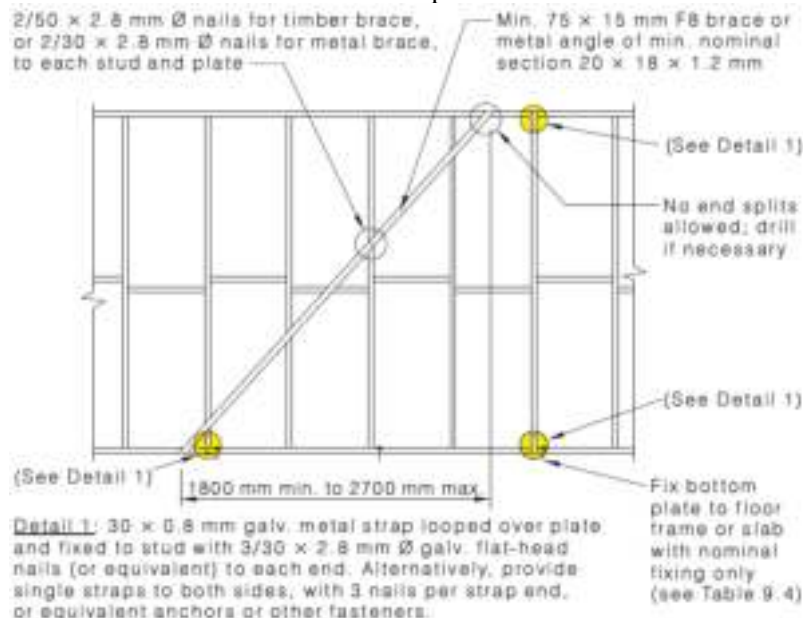
16. Angle Brace Nailing

The angle bracing has only been fixed to the studs with one nail (or none).

Area: Top of entry coat cupboard wall

It is a requirement of Australian Standard, AS 1684 Residential Timber-Framed Construction, that there be a minimum of 2/30 x 2.8mm nails to each stud and plate.

There must be additional nails installed in accordance with AS 1684.

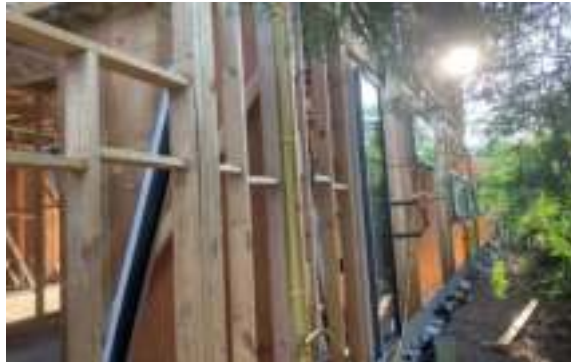
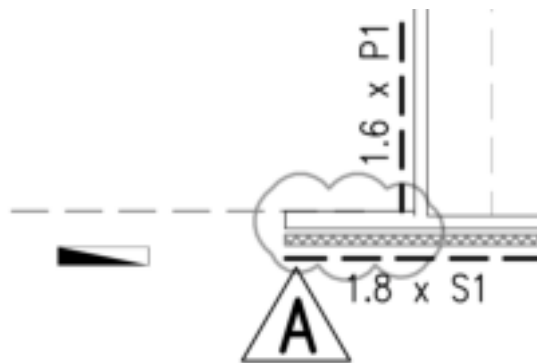
17. Engineering Brace Missing

The bracing detailed on the engineering drawings has not been installed as specified.
Area: "S1" brace missing to master/WIR external wall

This will need to be re-constructed on site to reflect the designed requirements of the approved drawings, or otherwise be re-designed and certified by the original design engineer. The building permit may also need to be amended by the relevant building surveyor to reflect the changes to the approved drawings.

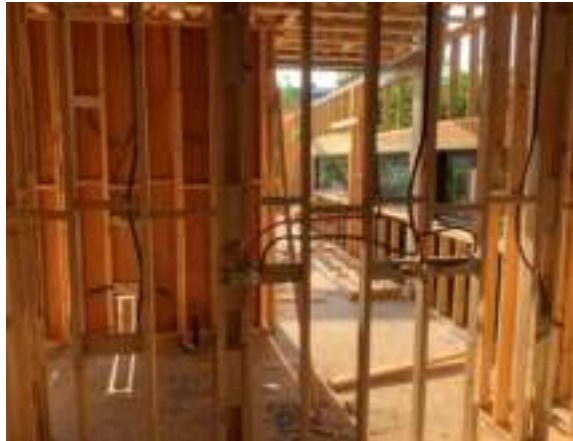
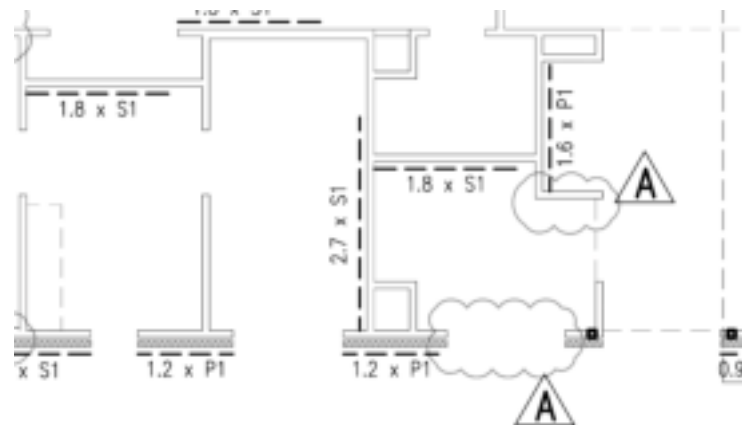
19. Engineering Brace Missing

The bracing detailed on the engineering drawings has not been installed as specified.
 Area: "S1" brace missing to Ensuite/pantry wall

This will need to be re-constructed on site to reflect the designed requirements of the approved drawings, or otherwise be re-designed and certified by the original design engineer. The building permit may also need to be amended by the relevant building surveyor to reflect the changes to the approved drawings.

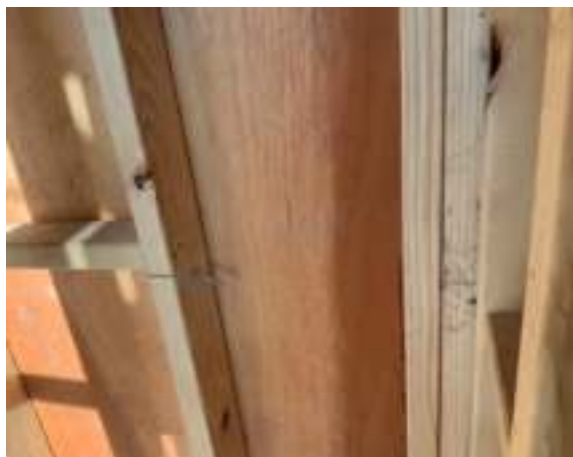
20. Nogging Missing

There is a nogging missing between the wall studs, allowing the studs to move behind the plaster sheeting, which could lead to the future cracking of the plaster joints.

Area: Laundry void

The relevant Australian Standard AS 1684 Residential Timber-Framed Construction – Simplified, clause 6.2.1.5 Nogging, states *'Wall studs shall have continuous rows of noggings, located on flat or on edge, at 1350mm maximum centres'*.

All missing wall noggings must be properly installed.

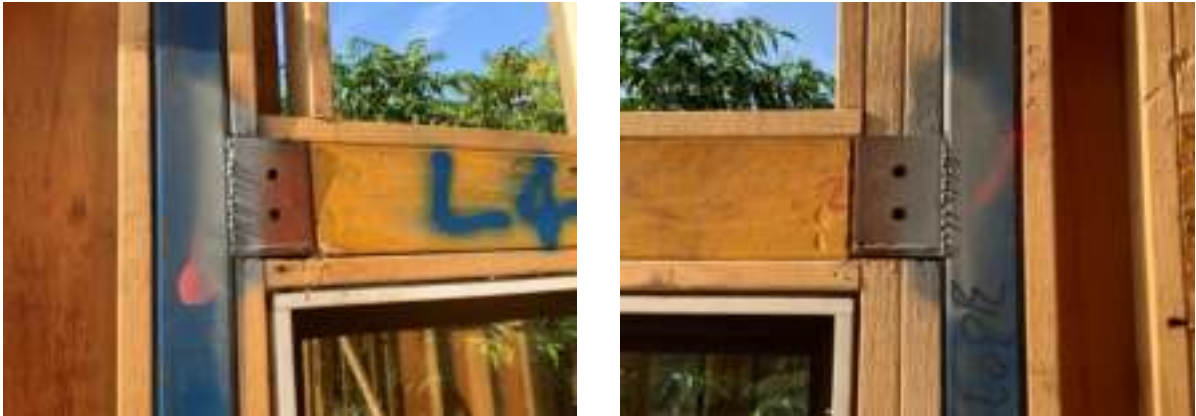
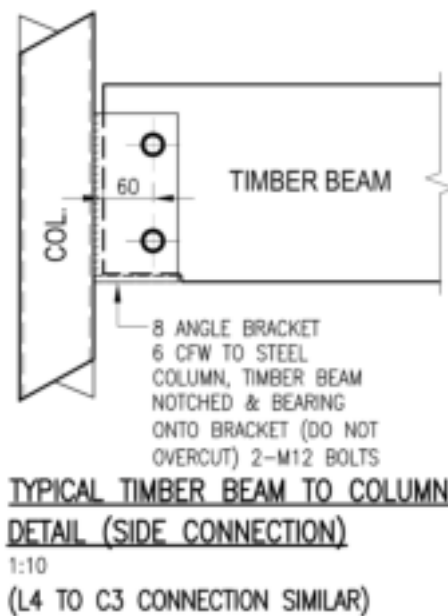
21. Engineering Beam Not Bolted

The steel beam has not been bolted as detailed on the engineering drawings.
Area: "L4" lintel over kitchen window

This will need to be re-constructed on site to reflect the designed requirements of the approved drawings, or otherwise be re-designed and certified by the original design engineer. The building permit may also need to be amended by the relevant building surveyor to reflect the changes to the approved drawings.

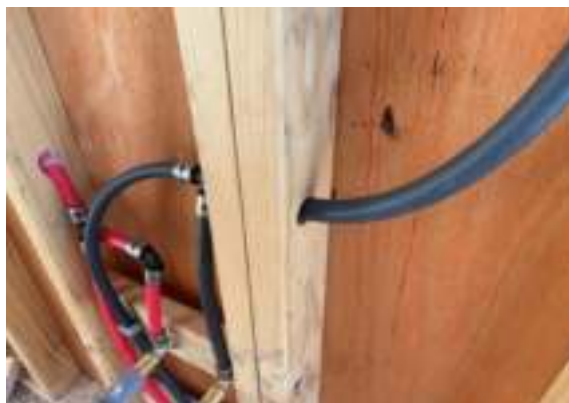
22. Pipe Movement in Frame

The water pipes need to have silicone or similar installed into the frame holes around the pipe to prevent movement and possible water hammer.

Area: Laundry trough area

The relevant Australian Standard AS 3500 Plumbing and Drainage, Part 1: Water Services, clause 5.4.2 Concealed piping, states that *'Where uninsulated pipes are used, a collar of lagging material or a neutral cure silicone sealant shall be used to fill the annular space'*.

All pipes that run through the frame must be fully secured in accordance with AS 3500.

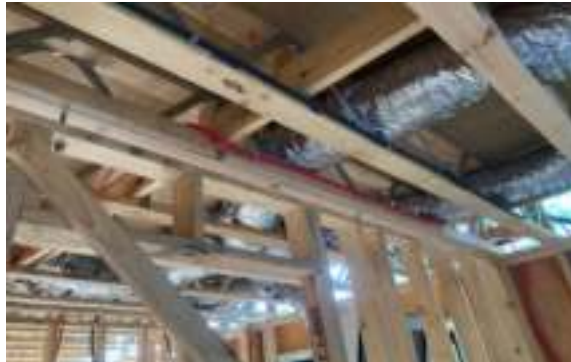
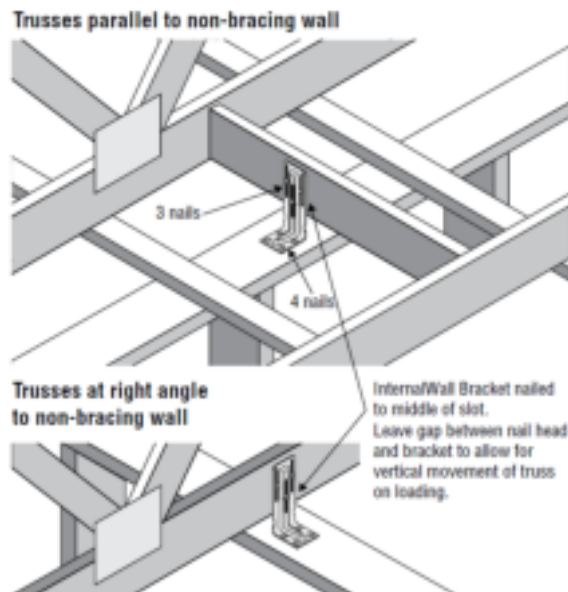
23. L Bracket Spacing

There are internal L-brackets that have been spaced at greater than the allowable 1800mm centres.
Area: Replace bolts with 'L' brackets on WIR/Ensuite wall

The truss manufacturers installation instructions state that *'If internal or non-load bearing walls are not designed as bracing walls, fix the truss with the Internal Wall Bracket with nails to middle of slots to allow for truss settlement as it is loaded. Brackets are fixed at 1.8m centres along unsupported sections of the wall. Where trusses are parallel to walls, trim between the bottom chords and fix brackets to the trimmer'*.

Additional brackets will have to be installed along these walls so that they are all spaced at no greater than 1800mm centres.

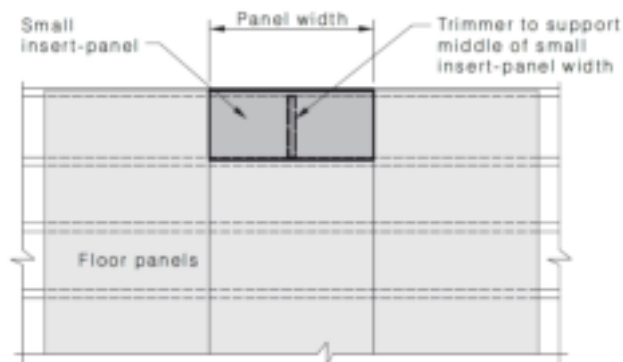
FIGURE 3 PANEL SPANNING TWO JOISTS ONLY—
TRIMMER TO SUPPORT MIDDLE OF PANEL

The relevant Australian Standard AS 1684 Residential Timber-Framed Construction, clause 5.5.4.2 Particleboard Laying states that '*Sheets shall span not less than two floor joist spacings*'.

Although this sheet should not be installed in this manner at all, Australian Standard AS 1860.2 Particleboard Flooring - Installation, clause 9.1 Panel Installation, requires that '*Where possible, each panel shall be supported by not less than three joists. Where this arrangement is not possible, or where small insert-panels are necessary for finishing off the floor area, panels spanning only two joists shall be additionally supported by a trimmer, not less than 70 mm × 35 mm, fixed between these two joists to support the middle of the panel (see Figure 3)*'.

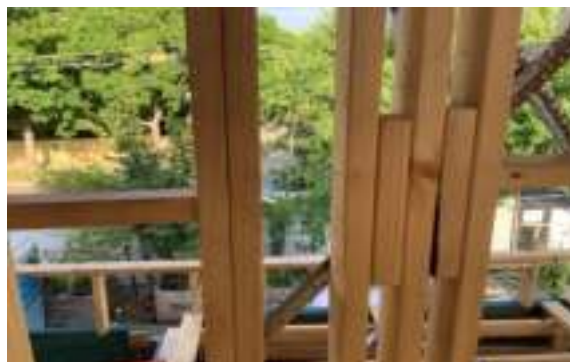
26. Nogging Missing

There is a nogging missing between the wall studs, allowing the studs to move behind the plaster sheeting, which could lead to the future cracking of the plaster joints.

Area: Leisure front wall

The relevant Australian Standard AS 1684 Residential Timber-Framed Construction – Simplified, clause 6.2.1.5 Nogging, states '*Wall studs shall have continuous rows of noggings, located on flat or on edge, at 1350mm maximum centres*'.

All missing wall noggings must be properly installed.

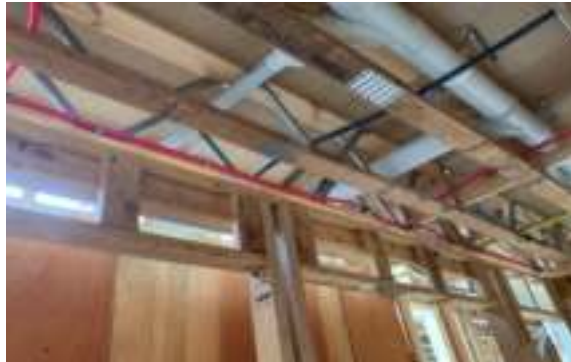
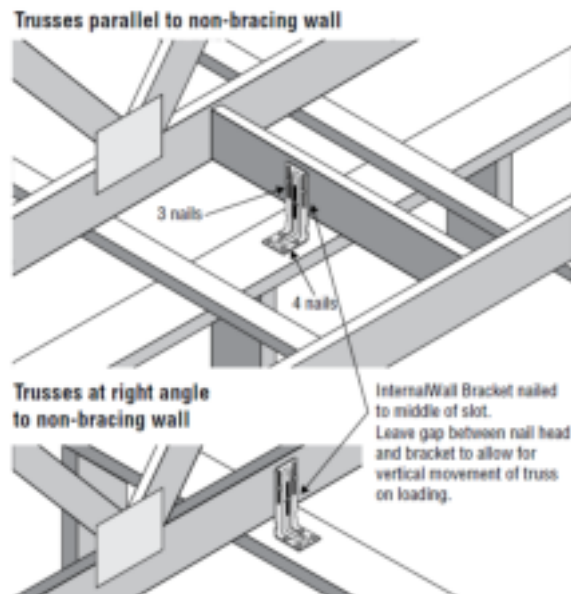
There are internal L-brackets that have been spaced at greater than the allowable 1800mm centres.
Area: Replace bolts with 'L' brackets on Laundry linen wall

The truss manufacturers installation instructions state that *'If internal or non-load bearing walls are not designed as bracing walls, fix the truss with the Internal Wall Bracket with nails to middle of slots to allow for truss settlement as it is loaded. Brackets are fixed at 1.8m centres along unsupported sections of the wall. Where trusses are parallel to walls, trim between the bottom chords and fix brackets to the trimmer'*.

Additional brackets will have to be installed along these walls so that they are all spaced at no greater than 1800mm centres.

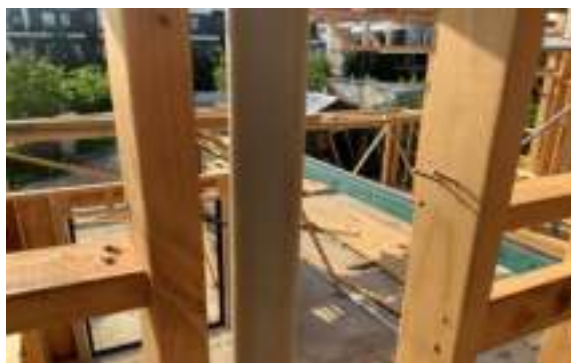
28. Nogging Missing

There is a nogging missing between the wall studs, allowing the studs to move behind the plaster sheeting, which could lead to the future cracking of the plaster joints.

Area: Bathroom external wall

The relevant Australian Standard AS 1684 Residential Timber-Framed Construction – Simplified, clause 6.2.1.5 Nogging, states *'Wall studs shall have continuous rows of noggings, located on flat or on edge, at 1350mm maximum centres'*.

All missing wall noggings must be properly installed.

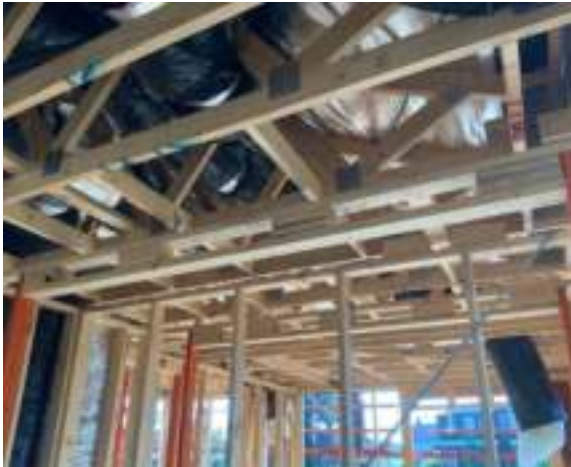
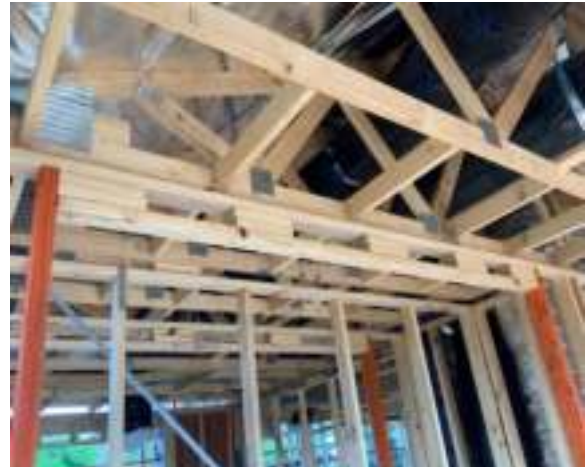
There are non-loadbearing walls with an opening greater than 1.8m wide that don't contain a lintel.
Area: Bed 2 & 3 robes

It is a requirement of Australian Standard AS 1684 Residential Timber-Framed Construction, clause 6.3.6.5 Lintels in Non-Loadbearing Internal Walls that *'Where wall openings wider than 1800mm occur in non-loadbearing walls, a lintel shall be provided and the size of the lintel shall be determined from Span Table 23'*.

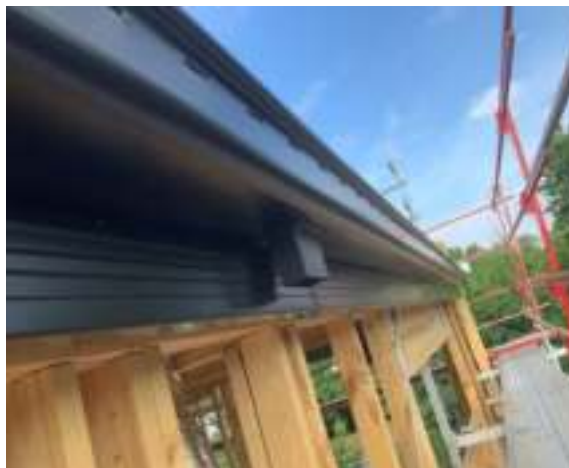
There are downpipes that have not been fitted, continuing to direct water onto the ground adjacent to the footings, which could cause future slab heave/structural movement issues.

The builder must immediately fit downpipes to the gutters to prevent future structural movement issues.

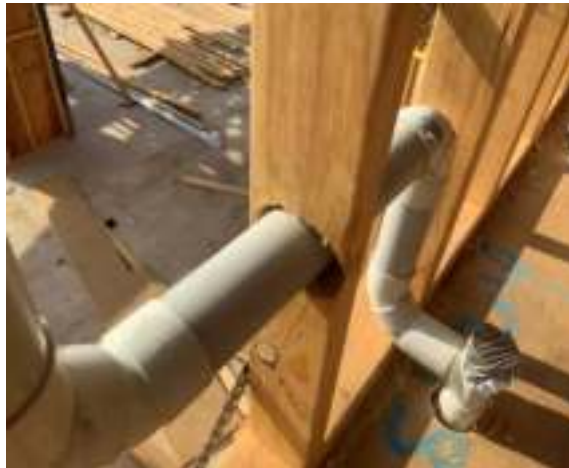
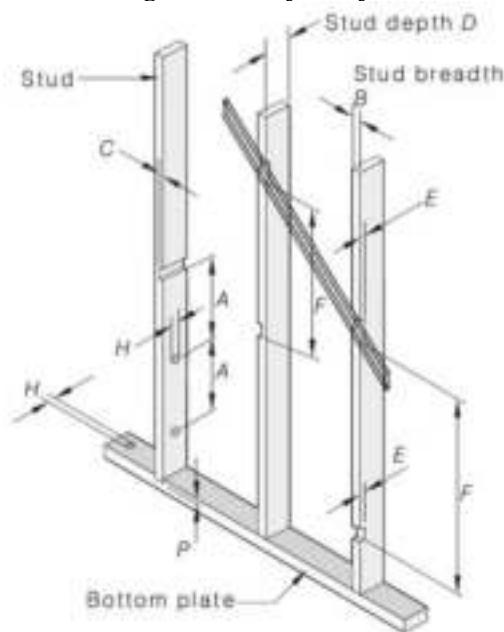
Area: Bathroom external wall

The relevant Australian Standard AS 1684 Residential Timber-Framed Construction, clause 6.2.1.4 Notching, Trenching and Holes in Studs and Plates states that *'Holes in studs and plates shall be located within the middle half of the depth and breadth of the member respectively, and that a maximum hole of 25mm in diameter may be drilled through the wide face of a stud'*.

These wall studs will have to be properly strengthened or replaced.

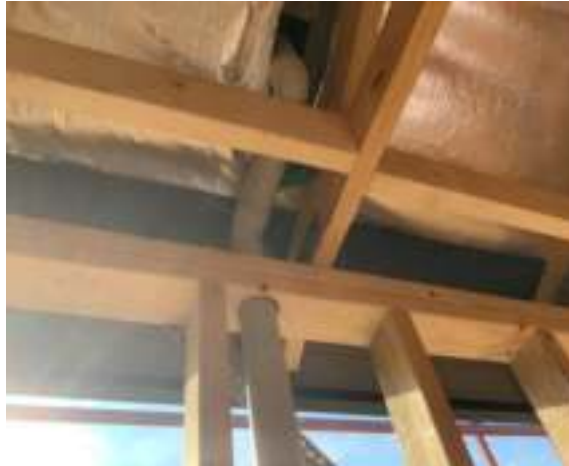
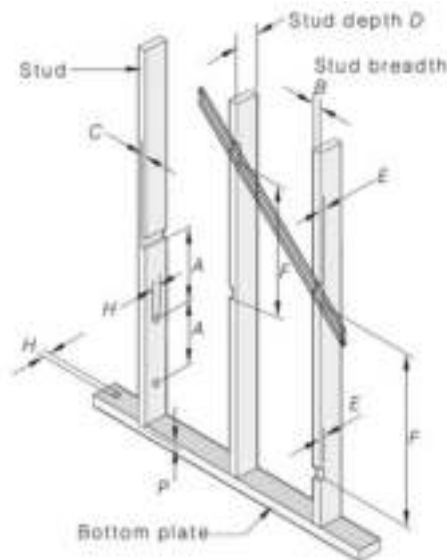
Area: Bathroom wall for sewer vent

The relevant Australian Standard AS 1684 Residential Timber-Framed Construction, clause 6.2.1.4 Notching, Trenching and Holes in Studs and Plates states that *'Holes in studs and plates shall be located within the middle half of the depth and breadth of the member respectively, and that a maximum hole of 25mm in diameter may be drilled through the wide face of a plate'*. It also notes that *'Top and bottom plates in internal non-loadbearing and non-bracing walls may be discontinuous up to 60mm (cut or drilled) to permit installation of services provided that, at the discontinuity, the plates are trimmed or otherwise reinforced either side of the discontinuity to maintain the lateral and longitudinal integrity of the wall'*.

These top plates will have to be properly strengthened or replaced.

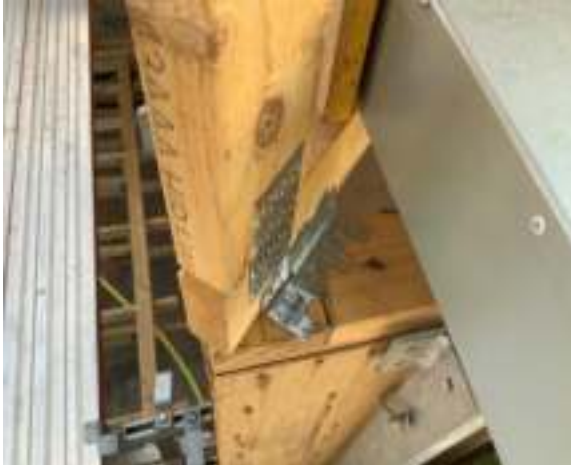
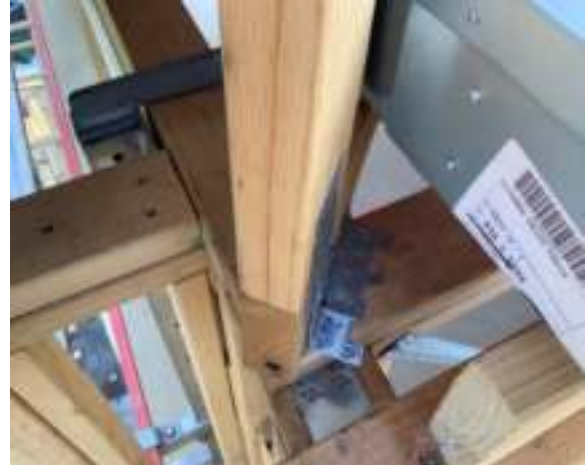
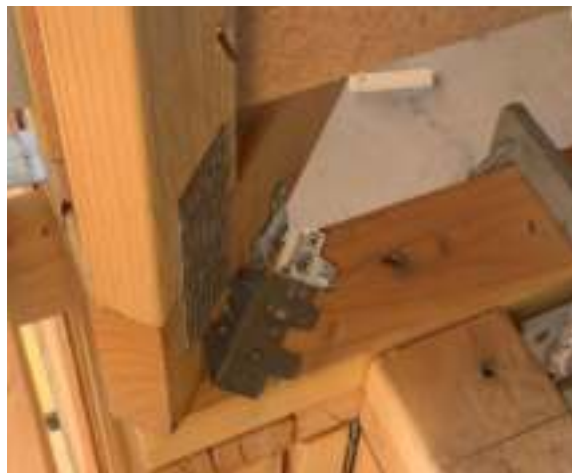
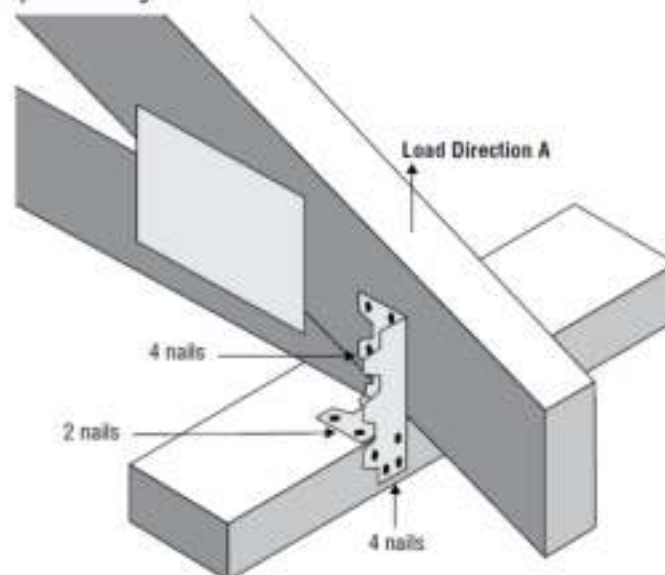
There are trip-l-grips designed to hold down the hip roof trusses throughout this home that have been installed on their flat, which is not the correct orientation.

The truss manufacturer's installation instructions require four nails into the side of the top plates, two into the top of the top plate, and four into the side of the truss, as per their detail below;

These brackets will need to be replaced in the correct orientation, with the appropriate number of nails fitted through each section of the trip-l-grips in accordance with the truss manufacturer's requirements. Alternatively, the builder should provide the owner documentation from the truss manufacturer to confirm that the currently installed brackets are acceptable.

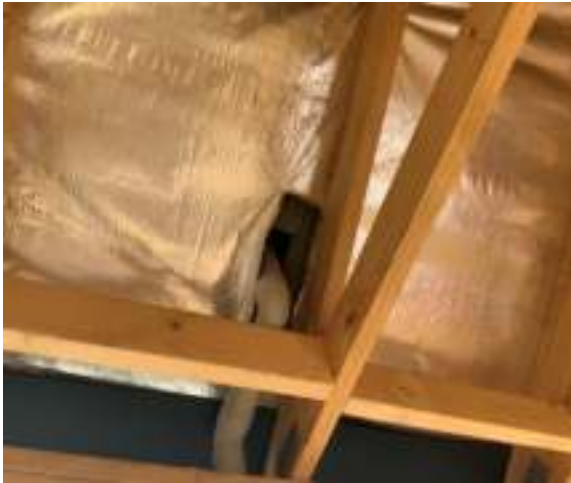
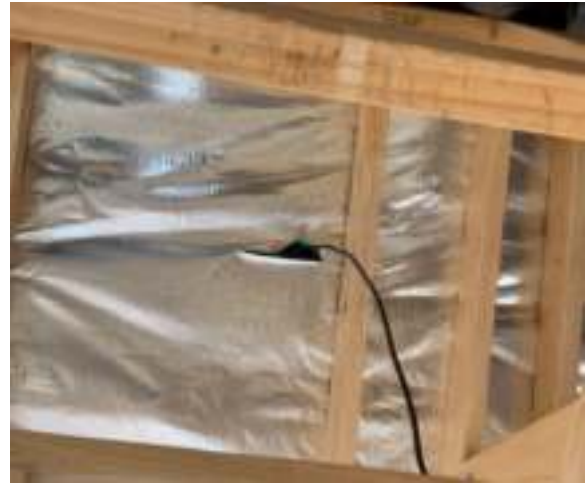
The roof sarking at the penetration of the services have not been turned back up to drainage around them properly, which will allow condensation to drip onto the ceilings.

The relevant Australian Standard AS 4200.2 Pliable Building Membranes and Underlays, Part 2: Installation Requirements states that *'penetrations shall be either sealed or turned up to facilitate drainage around a penetration'*.

Additionally, Australian Standard AS 2050 Installation of Roof Tiles, Section 3 Installation, clause 3.1.3 Damage states that *'Care shall be taken to avoid damaging the sarking during installation or tile-installing operations. Any tears or punctures, other than those caused by the installation of fixing over rafters, shall be repaired with a purpose-made sarking tape'*.

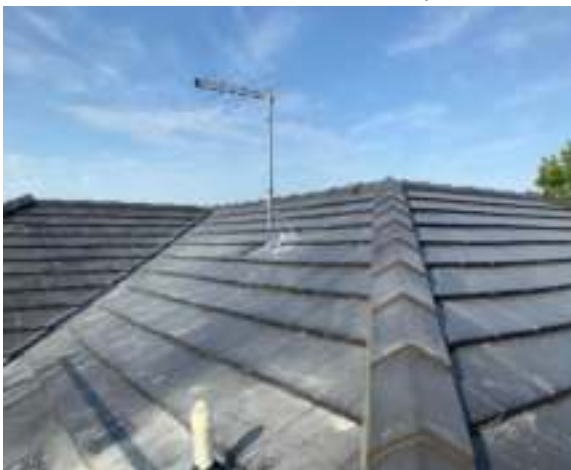
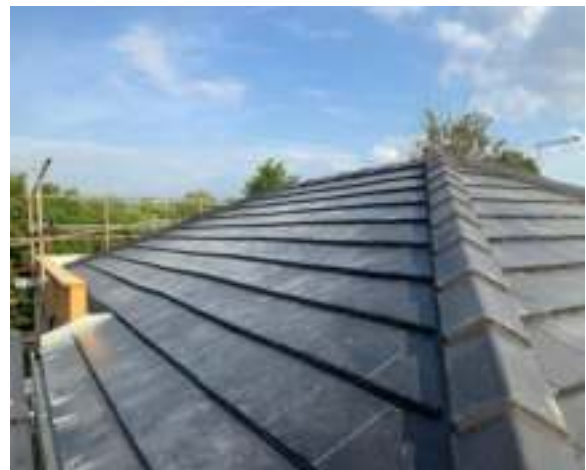
35. Roof Ventilator Missing

The NCC's Building Code of Australia 2016 (BCA) states in section 3.8.5.2(c) that;

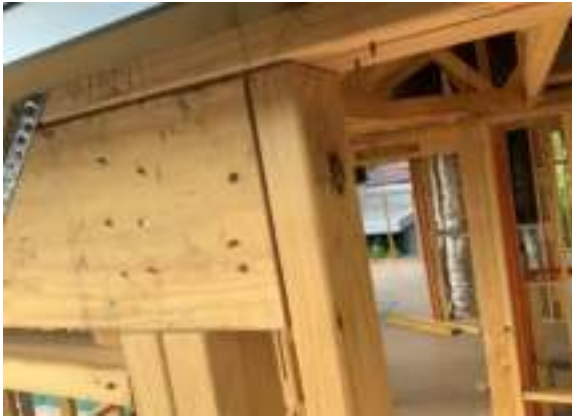
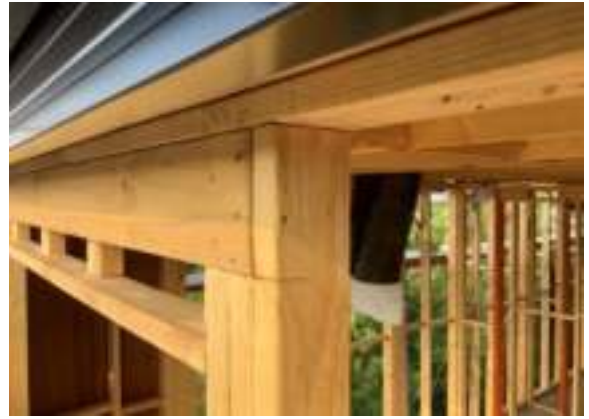
The relevant Australian Standard AS 1684 Residential Timber-Framed Construction requires in section 9.5 Nominal Fixings that lintels are fixed through their jamb studs with at least 2/75mm nails.
