FRAME INSPECTION REPORT & DEFECTS LIST

TABLE OF CONTENTS

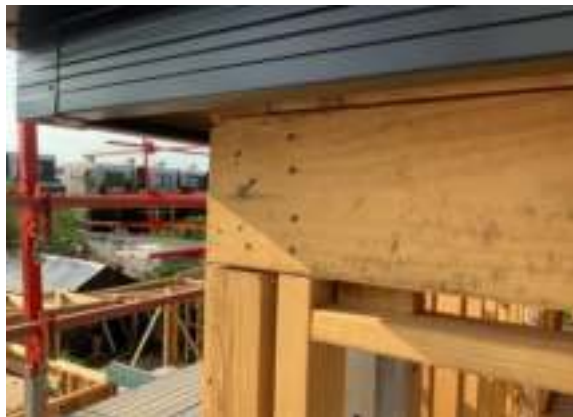
37. Lintel Carry Stud Missing

Area: Bathroom window

It is a requirement of AS 1684 Residential Timber-Framed Construction, clause 6.3.2.3 Jamb Studs (studs at sides of openings), that *'openings are to have 1 full-length stud on either side of the openings'*.

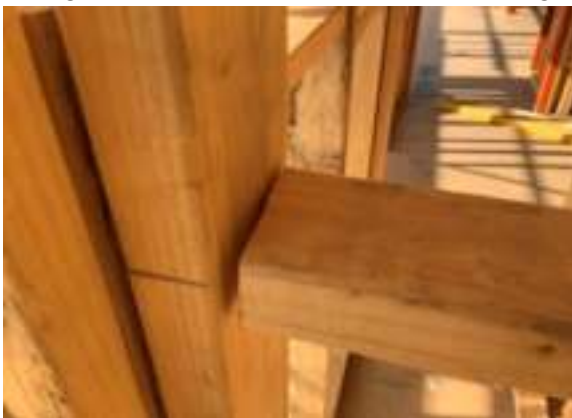
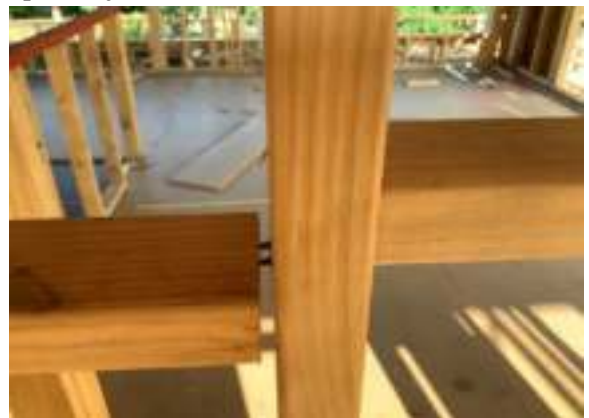
There are noggings between the wall studs that are short, allowing the studs to move behind the plaster sheeting, which could lead to the future cracking of the plaster joints.

The relevant Australian Standard AS 1684 Residential Timber-Framed Construction – Simplified, clause 6.2.1.5 Nogging, states *'Wall studs shall have continuous rows of noggings, located on flat or on edge, at 1350mm maximum centres'*.

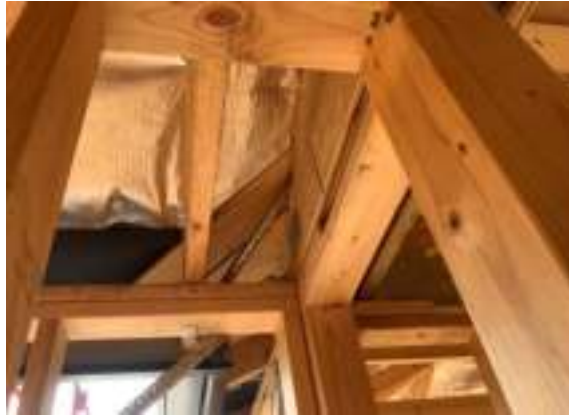
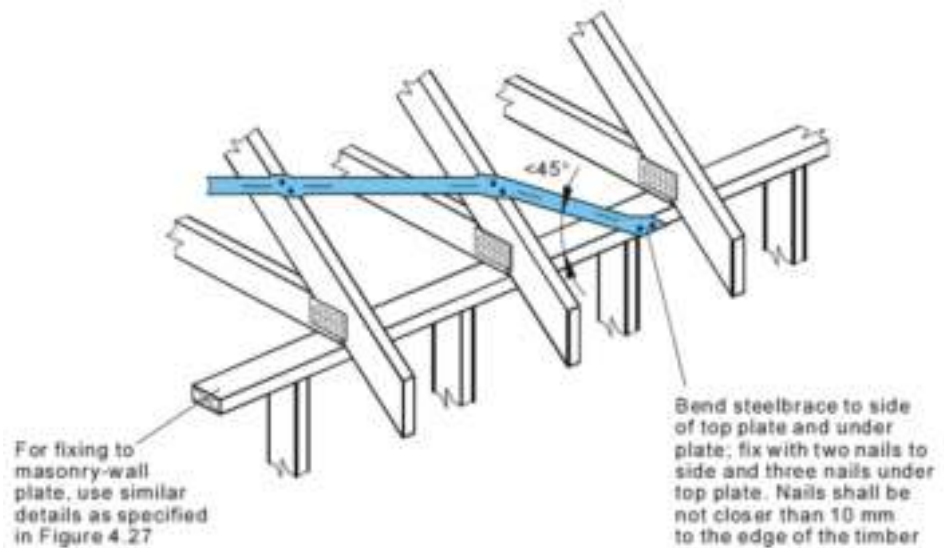
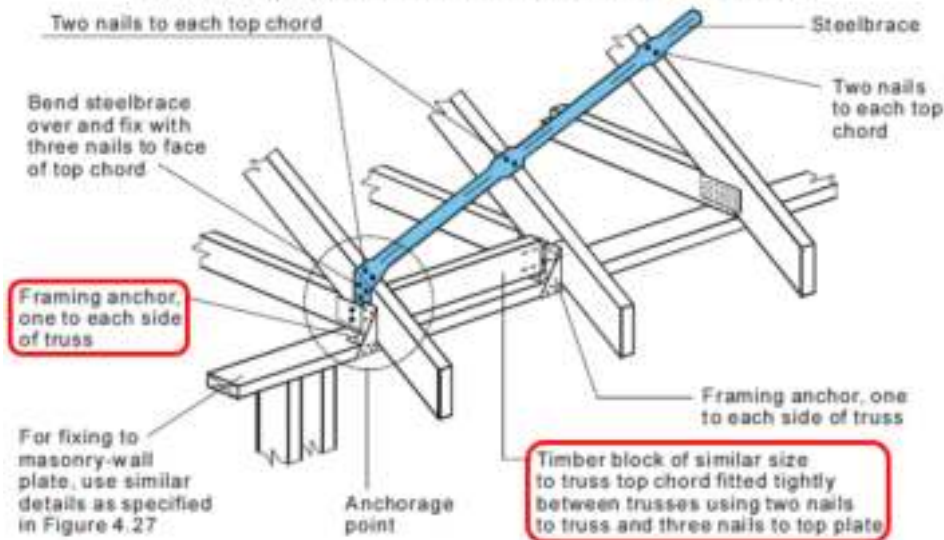
The relevant Australian Standard, AS 4440 Installation of Nail-Plated Timber Roof Trusses, clause 4.3.8 Fixing, provides a detail outlining the method for connecting speedbrace to the top plate at the heel;
