FRAME INSPECTION REPORT & DEFECTS LIST

TABLE OF CONTENTS

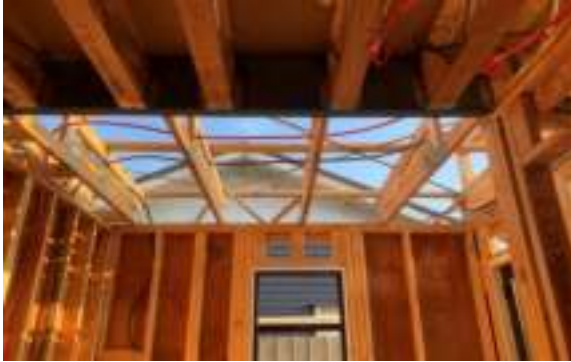
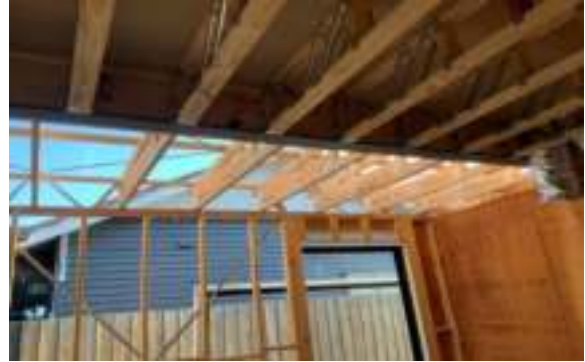
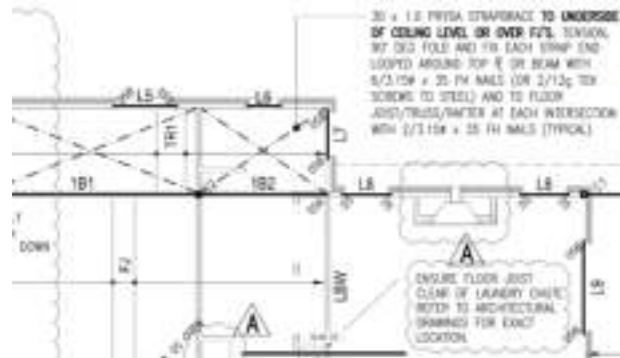
Area: The ceiling braces specified over the study & laundry areas have not been installed.

The bracing has not been constructed as detailed on the engineering drawings.

This will need to be re-constructed on site to reflect the designed requirements of the approved drawings, or otherwise be re-designed and certified by the original design engineer. The building permit may also need to be amended by the relevant building surveyor to reflect the changes to the approved drawings.

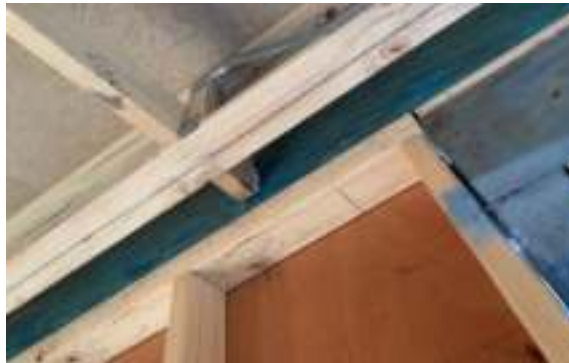
Area: Study

7. Posi Truss Strongback to Beam

The strongbacks have not been properly fixed to the timber beams.

The manufacturer states that ***'Strongbacks significantly dampen vibrations and increase the stiffness of the floor system. The performance of the floor depends very much on the proper installation of Strongbacks'***.

The strongback must be properly fixed in accordance with the manufacturer's instructions to ensure the performance of the floor frame system.

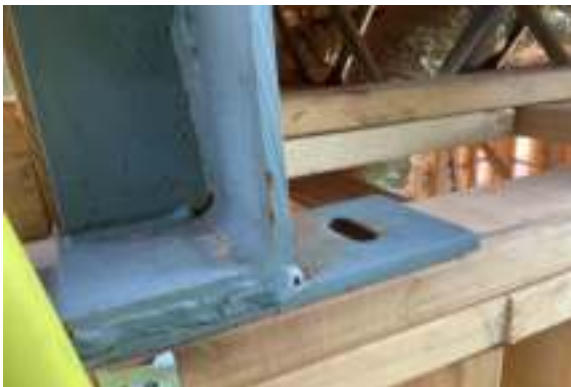
Area: “1B5” to wall in master suite

This engineered connection has not been constructed as detailed on the engineering drawings.

This will need to be re-constructed on site to reflect the designed requirements of the approved drawings, or otherwise be re-designed and certified by the original design engineer. The building permit may also need to be amended by the relevant building surveyor to reflect the changes to the approved drawings.

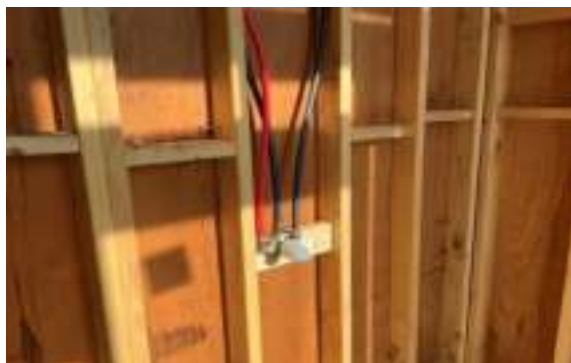
18. Nogging Alignment

There are wall noggings that are offset or staggered from the ones beside it by up to 500mm.
Area: Laundry

The relevant Australian Standard AS 1684 Residential Timber-Framed Construction, clause 6.2.1.5 Nogging, states '*Noggings may be installed anywhere in the depth of the stud. Stagger in the row of noggings shall be not greater than 150mm*'.

These noggings must be correctly aligned with the abutting ones in accordance with above.

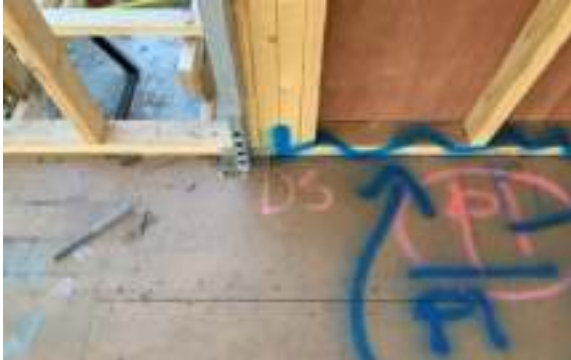
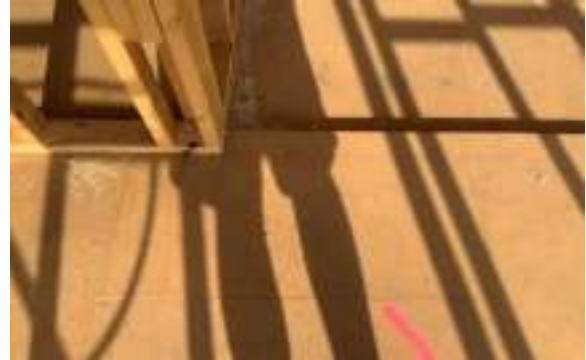
25. Single Span Flooring

There are areas in the flooring where there is a single span sheet of chipboard flooring only supported by two joists (one spacing), and there has not been any additional framing installed to properly support them.

The relevant Australian Standard AS 1684 Residential Timber-Framed Construction, clause 5.5.4.2 Particleboard Laying states that '*Sheets shall span not less than two floor joist spacings*'.

Although this sheet should not be installed in this manner at all, Australian Standard AS 1860.2 Particleboard Flooring - Installation, clause 9.1 Panel Installation, requires that '*Where possible, each panel shall be supported by not less than three joists. Where this arrangement is not possible, or where small insert-panels are necessary for finishing off the floor area, panels spanning only two joists shall be additionally supported by a trimmer, not less than 70 mm × 35 mm, fixed between these two joists to support the middle of the panel (see Figure 3)*'.
